Manhole Inspection Summary

Manhole # S47C__038MH

Insp Date: 7/11/08 9:30 AM

Location Address: **Patterson Park**

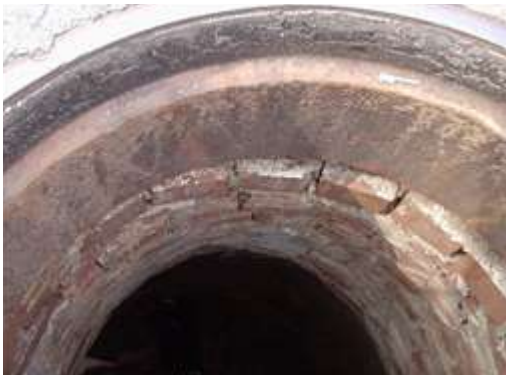
Defect 2

Condition: ☐ Sound ☐ Cracked ☐ Root Intrusion ☒ **Loose Brick** ☐ Deteriorated

loose brick

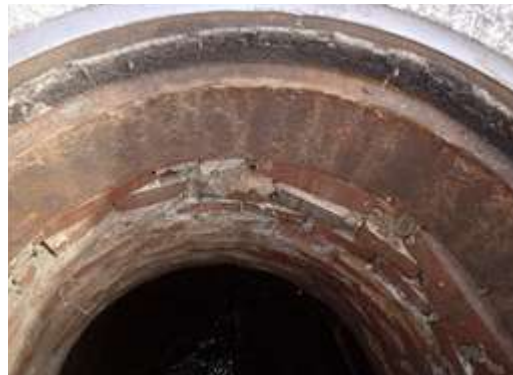
Defect 1

☒ **Leaks**

frame leaks, loose bricks

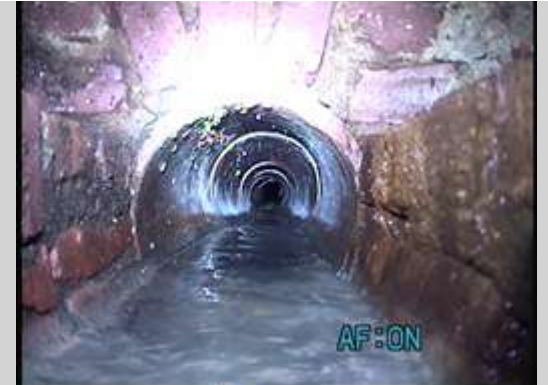
12 O'Clock Outflow

Pipe Height: **8.4** (in.) Rod and Bar (Angled)
Pipe Material: **Clay** ☐ Pipe Lined
Invert Depth: **9.60** (ft.) Flow Characteristics: **Fast**
Deposits: ☒ None ☐ Mud ☐ Sludge ☐ Debris ☐ Grease
Silt Depth: (in.) Deposits Extent:
Infiltration: **None** Pipe Seal Cond: **Sound**

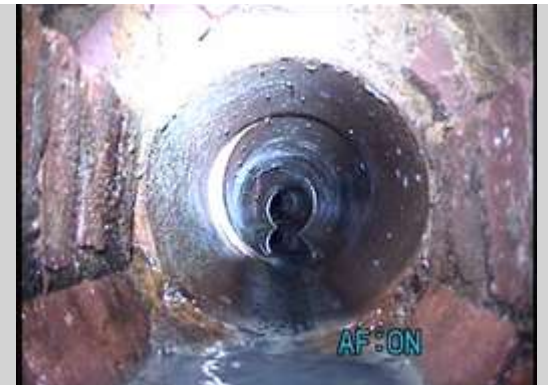
6 O'Clock Inflow

Pipe Height: **8.4** (in.) Rod and Bar (Angled)
Pipe Material: **Clay** ☐ Pipe Lined
Invert Depth: **9.50** (ft.) Flow Characteristics: **Fast**
Deposits: ☒ None ☐ Mud ☐ Sludge ☐ Debris ☐ Grease
Silt Depth: (in.) Deposits Extent:
Infiltration: **None** Pipe Seal Cond: **Sound**

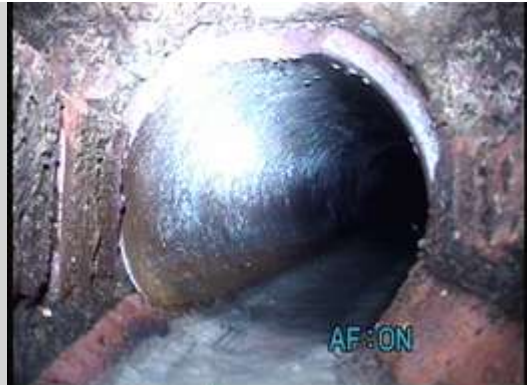
9 O'Clock Inflow

Infiltration: **None** Pipe Seal Cond: **Sound**
